**DYERS RUN NO. 3 DAM**

(NDI NO. PA-00676

**PHASE I INSPECTION REPORT,**

(11) **FEBRUARY 1981**

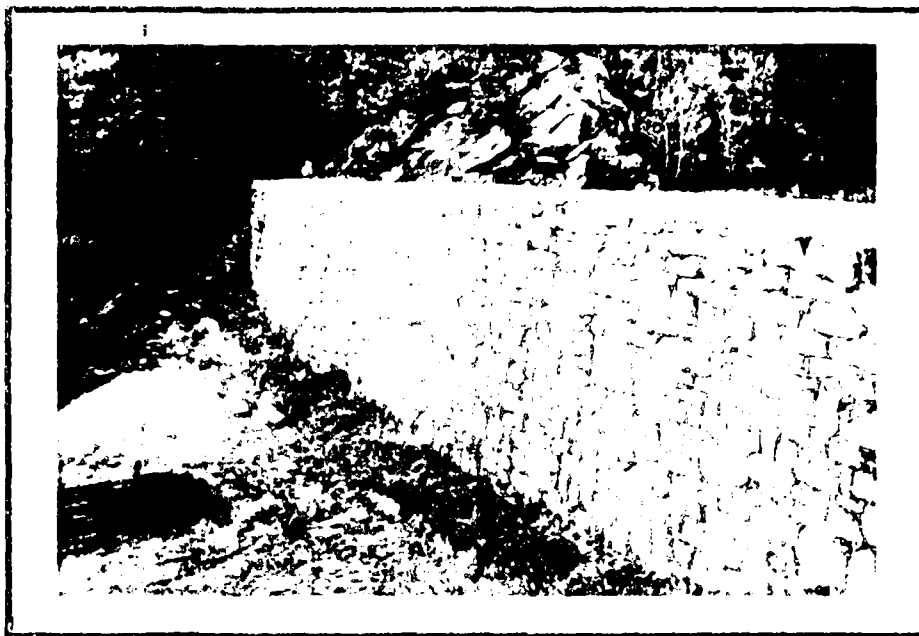
DOWNSTREAM MASONRY WALL  
LOOKING TO RIGHT ABUTMENT - NO. 2

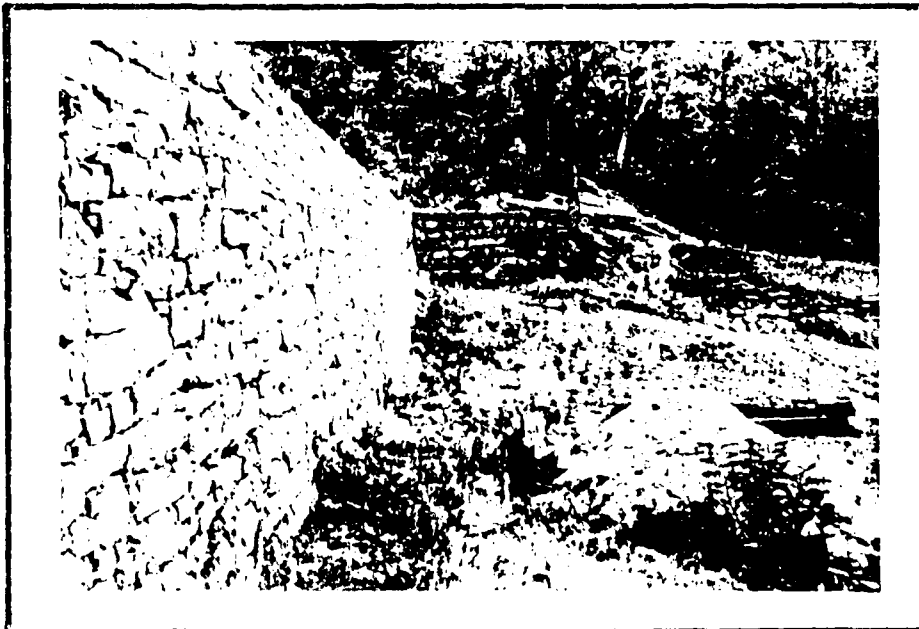
LOOKING TO LEFT ABUTMENT - NO. 3

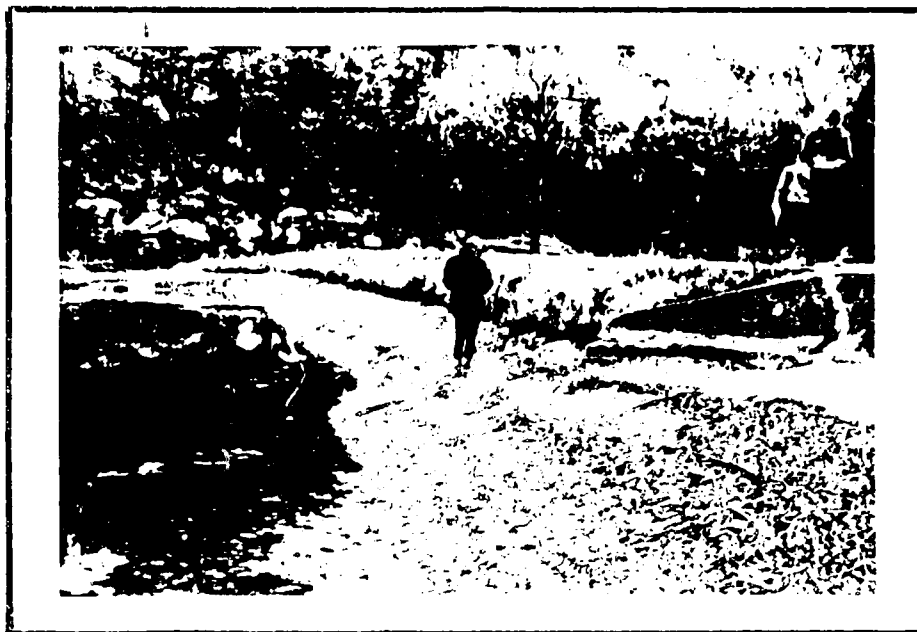
The broad crested spillway weir is located in the right abutment and is constructed of large stone slabs (Photograph No. 6). On the right side, the abutment is formed by natural rock. On the left side there is a small concrete wingwall in the forebay which has cracked (Photograph No. 4). This condition gives a poor appearance, but does

The spillway weir and discharge channel are in good condition. There were no signs of instability except that the left forebay wall had settled and cracked. The impervious blanket is upstream from the spillway and there were no signs of seepage from this area. Most of the spillway chute has a rock lined bottom.

UPSTREAM SLOPE AND LEFT SPILLWAY ABUTMENT WALL - NO. 4

1. That measures shall be taken to provide an adequate spillway capacity.
2. That the left forebay wall be repaired or replaced.
3. That the valves on the blow-off pipes be maintained and operated on a regular basis.

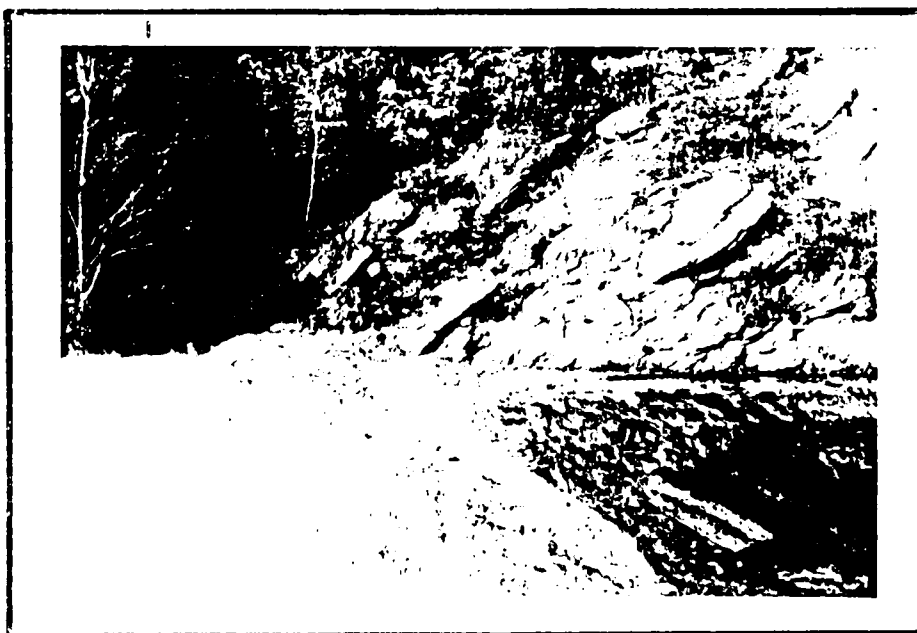
UPSTREAM AND RIGHT SPILLWAY ABUTMENT - NO. 5

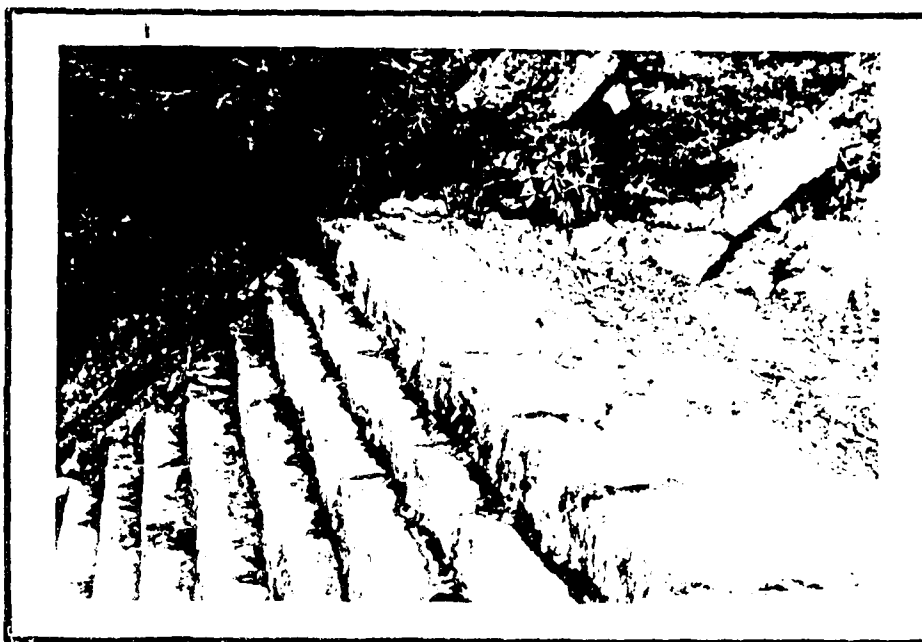
DOWNSTREAM STEPS OF SPILLWAY -- NC. 6

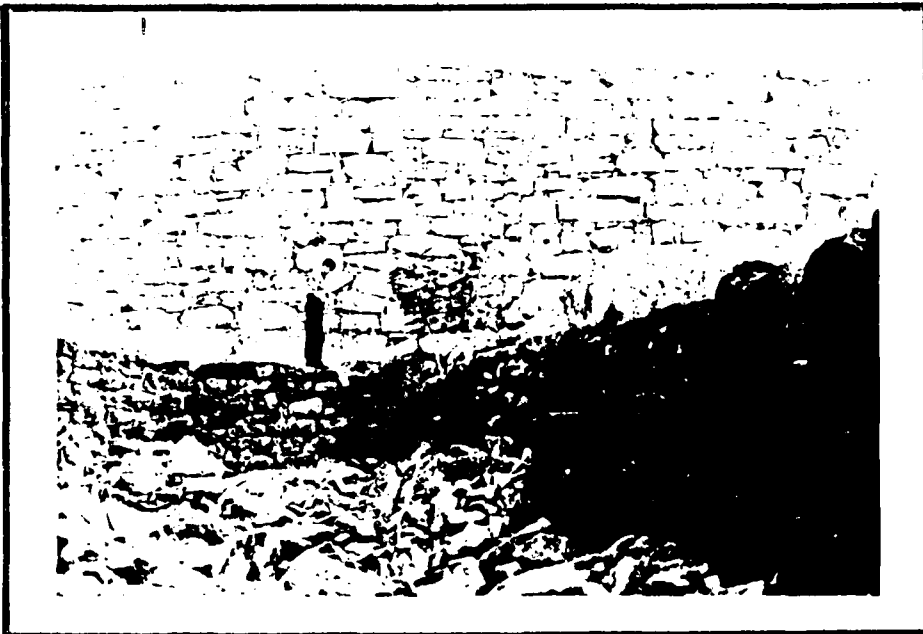
BLOW OFF PIPES OUTLET IN SPILLWAY CHANNEL - NO. 9

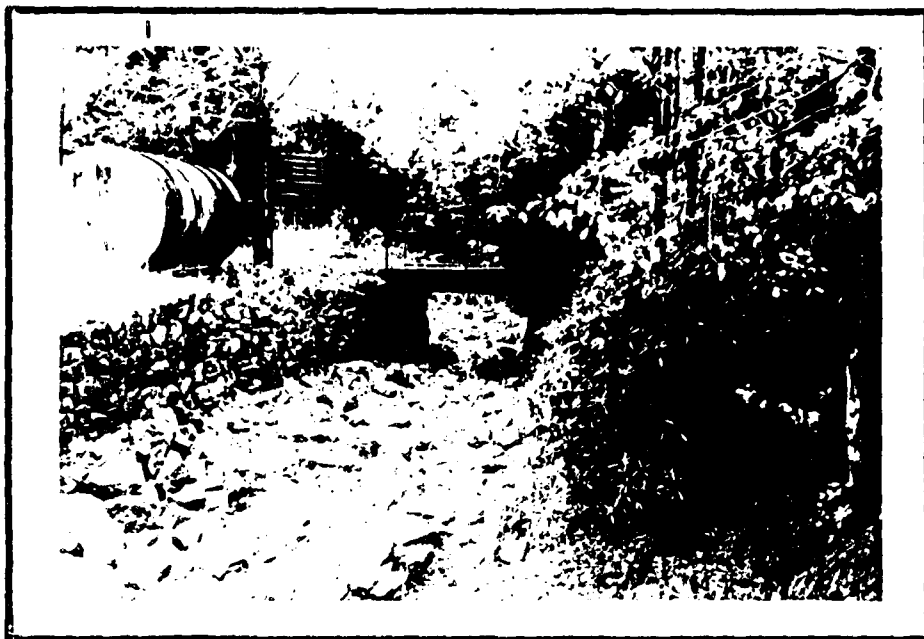
SPILLWAY OUTLET CHANNEL -- NO. 10
